## Cumberland Infirmary Car Parking Study

Survey Report  
September 2014

<b>Job No</b>	CS/075231-01		
<b>Project</b>	Cumberland Infirmary Car Parking Study		
<b>Location</b>	Carlisle, Cumbria		
<b>Title</b>	Survey Report		
<b>Document Ref</b>	Car Park Survey Report	<b>Issue / Revision</b>	Draft/Rev A
<b>File reference</b>	C:\Users\walter.aspinall\Documents\WFH\CS075231-01 - Cumberland Hospital Car Park Study\H7 - Documents & Specs\140905 Cumberland Infirmary Parking Report.docx		
<b>Date</b>	September 2014		
<b>Prepared by 1</b>	R Bbosa	Signature (for file)	RB
<b>Prepared by 2</b>		Signature (for file)	
<b>Prepared by 3</b>		Signature (for file)	
<b>Checked by</b>	J Sage	Signature (for file)	JS
<b>Checked by 1</b>		Signature (for file)	
<b>Authorised by</b>	W Aspinall	Signature (for file)	WA

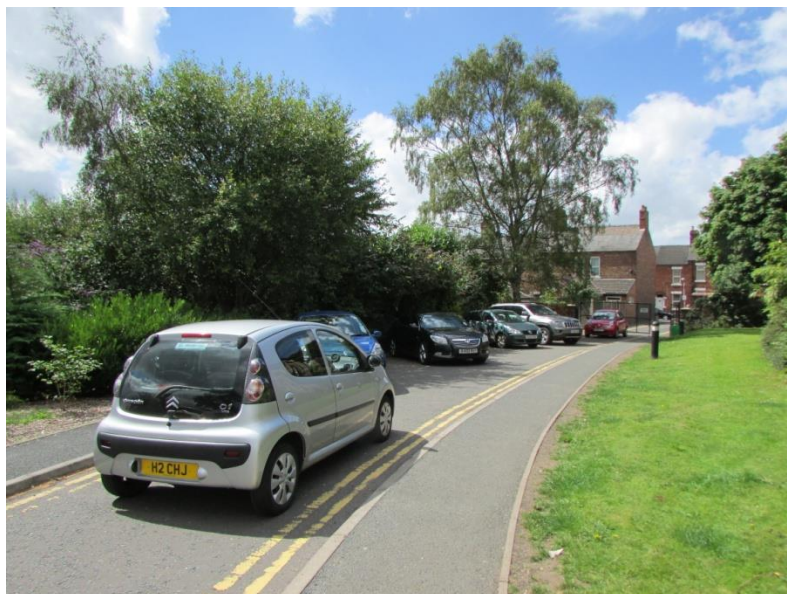
All of the Hospitals parking sites are surface level car parks which are currently observed to be over capacity at various times of the day. This leads to indiscriminate parking including access blocking, parking in car park running lanes and parking on grass verges as shown in Figure 2-2 below and Figure 2-3 and Figure 2-4 overleaf. The purpose of the surveys undertaken for this report is to evaluate the scale and duration of this problem.

**Figure 2-2: Indiscriminate Parking Blocking Access**

In order to develop a better understanding of the causes of the excessive parking demand and consider appropriate measures to alleviate these issues it is recommended that a more detailed study be undertaken. Such a study would consider the basis for the parking demand, the split between staff and visitor parking, car park management (including permits, parking charges and enforcement) and a range of possible solutions best suited to tackle the problem.

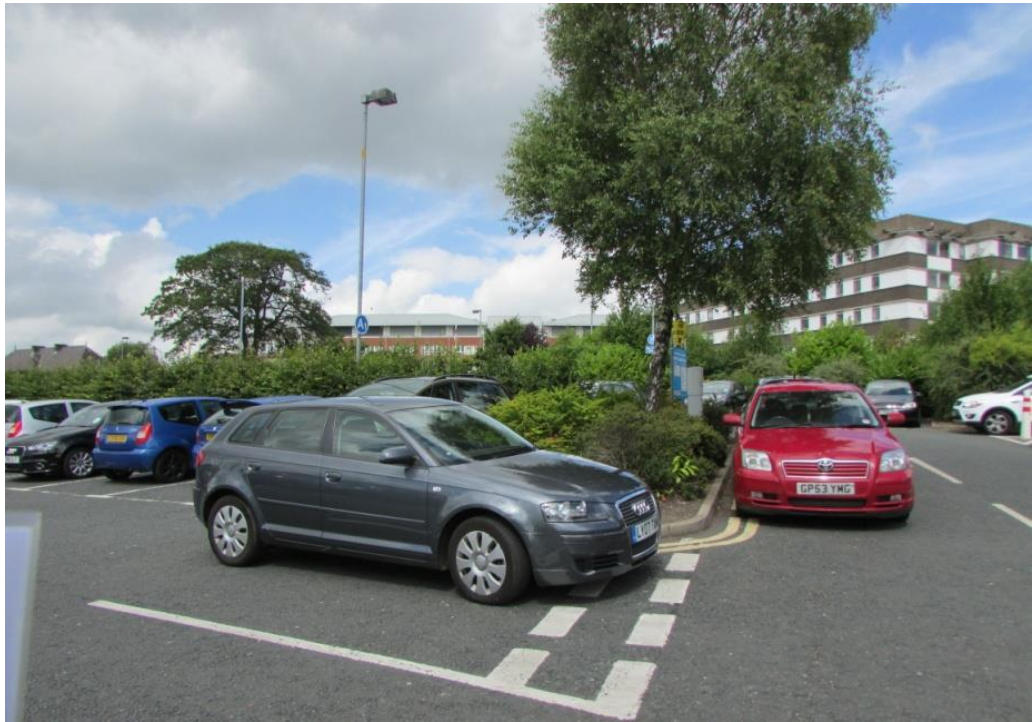
**Figure 2-3: Indiscriminate Parking within Parking Area**

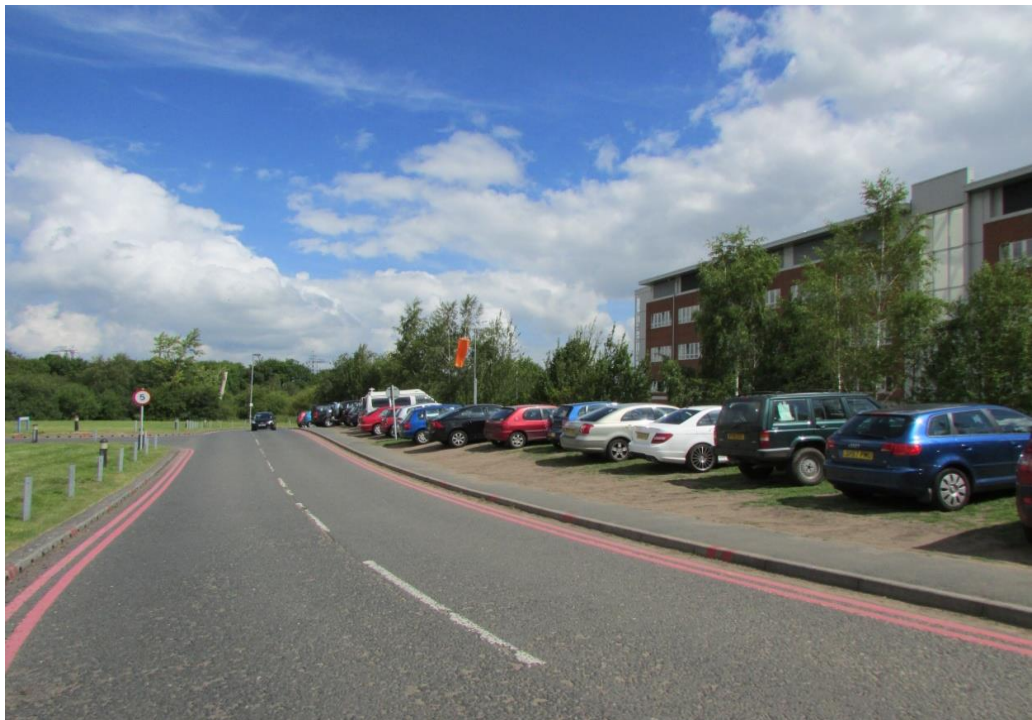
The car parks outside of the survey cordon have not been surveyed but are understood to experience similar issues to those within the cordon although less indiscriminate parking was observed in relation to these car parks during the site visit undertaken on 17<sup>th</sup> July 2014.

**Figure 2-4: Indiscriminate Parking on Grass Verge**

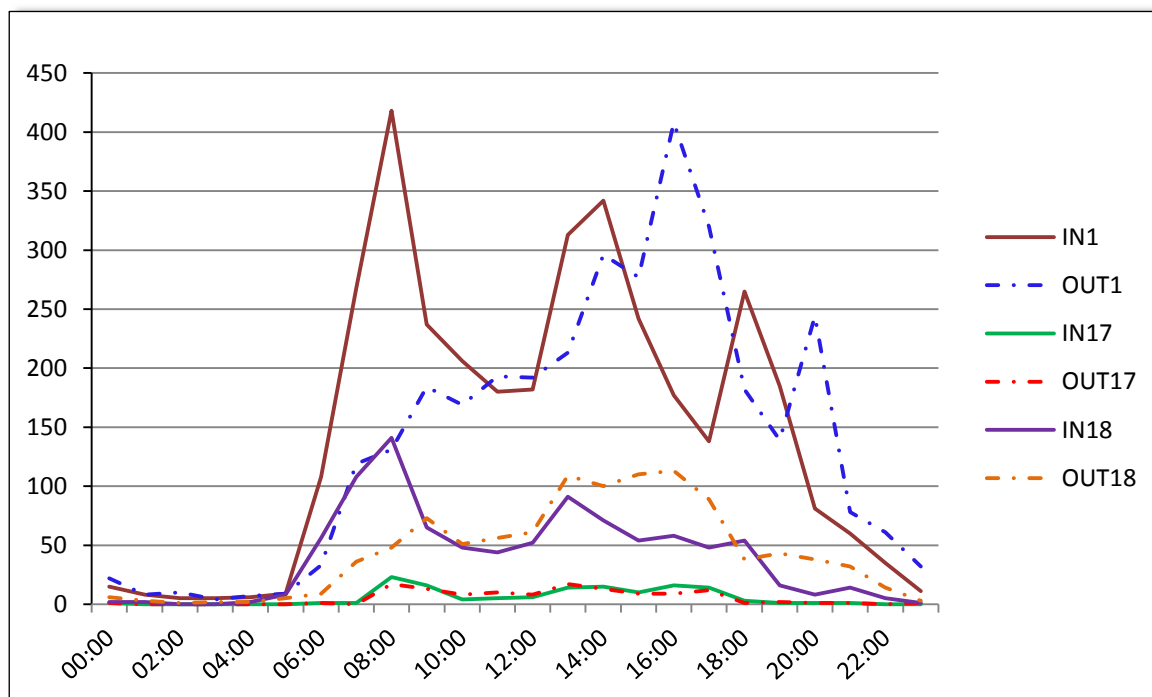
**Figure 4-1: Hourly Counts at Hospital Access Points**

The graph in Figure 4-1 below illustrates the data in Table 4-1 and clearly shows that access point *Site 1*, which is the main Hospital entry off Newtown Road carries the majority of traffic into and out of the hospital throughout the day, with *Site 18* carrying the least number of vehicles.

Figure 4-1 also shows that there are two significant peak periods that the hospital exhibits, which are at 08:00 and 16:00 hours. The morning peak period is mostly made up of arrivals with 582 vehicles entering the survey cordon. The afternoon peak period comprises mostly of departing vehicles with a maximum recorded number of departing vehicles being 530 between 16:00 – 17:00 hours.

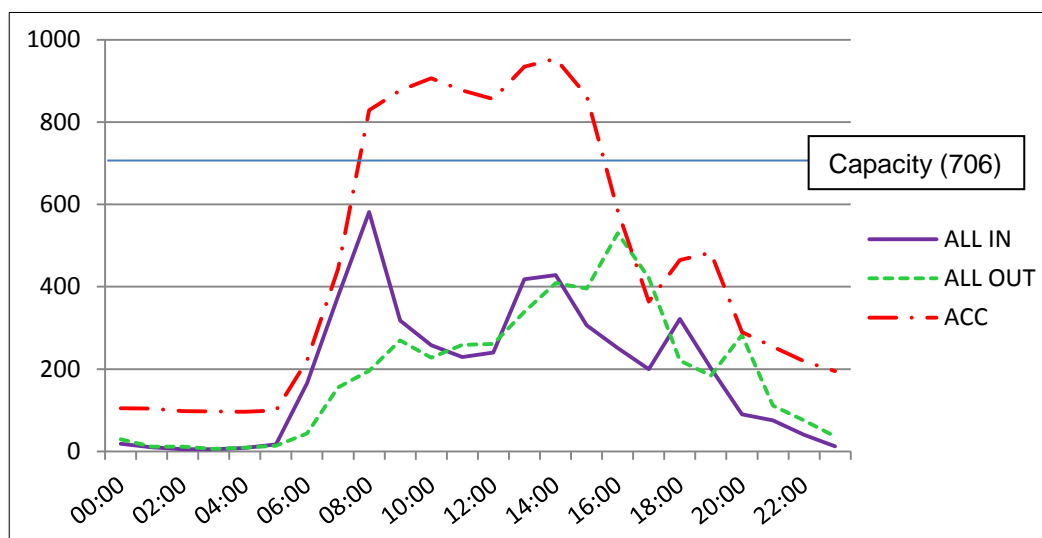
**Figure 4-2: Overall Hospital Vehicle Accumulation**

The general characteristic of the accumulation distribution is illustrated in Figure 4-2 overleaf. The graph tracks the relationship between the volume of traffic accessing and egressing the hospital site. The accumulation of vehicles within the survey cordon throughout the day has been profiled by adding the entries and subtracting the exits from the number of vehicles observed to be on site at the start of the survey period. This shows that the maximum number of parking spaces (706) within the cordon is exceeded between 08:00 and 16:00.

Further analysis indicates that the highest demand for car parking space was recorded between 1300 – 1400 hours. At this time the overall demand for parking within the cordoned area reached 138% of the available spaces. The lowest level of demand for parking spaces was recorded to be between 01:00 – 05:00 with a capacity of around 18%.

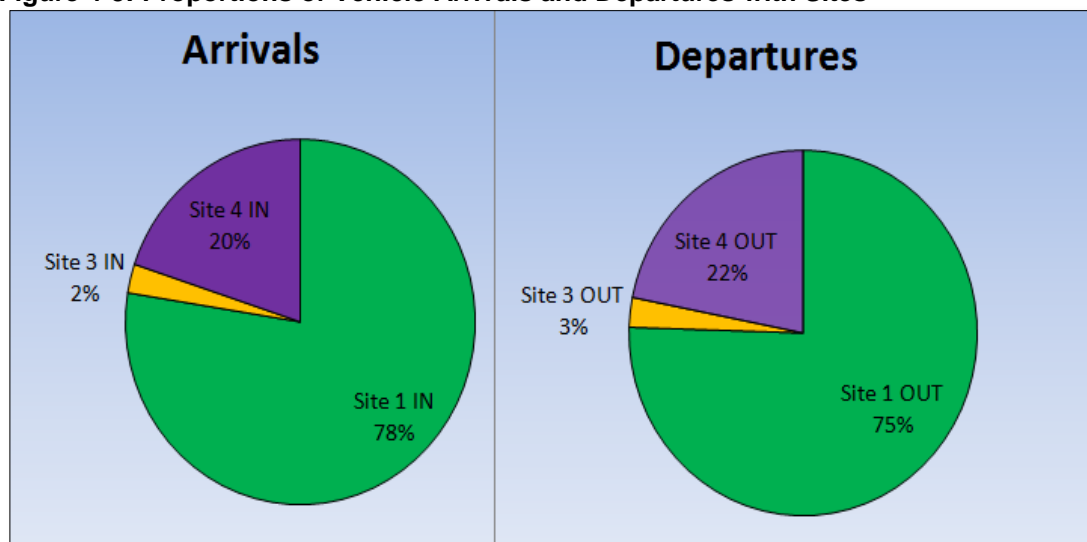
**Figure 4-3: Proportions of Vehicle Arrivals and Departures with Sites**

The Figure 4-3 above illustrates the proportion of vehicle arrivals and departures across the entry sites and it shows that majority of vehicles accessing the study area utilise the main Hospital access off Newtown Road and only 22% of vehicles accessing the hospital use the other two entry sites.

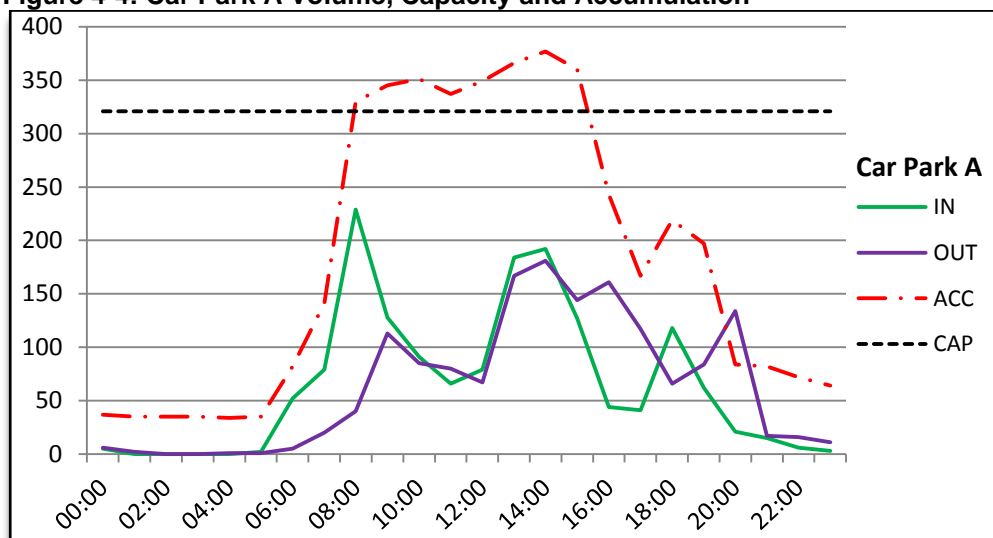
**Figure 4-4: Car Park A Volume, Capacity and Accumulation**

Occupancy of the car park at 00:00 hours was 38 vehicles from which time manual classified counts were made for every vehicle entering and exiting the car park. The survey results are summarised in Table 4-2 and Figure 4-4 overleaf. The results show that between 08:00 and 16:00 the car park is over capacity with peak occupancy of 117.5%.

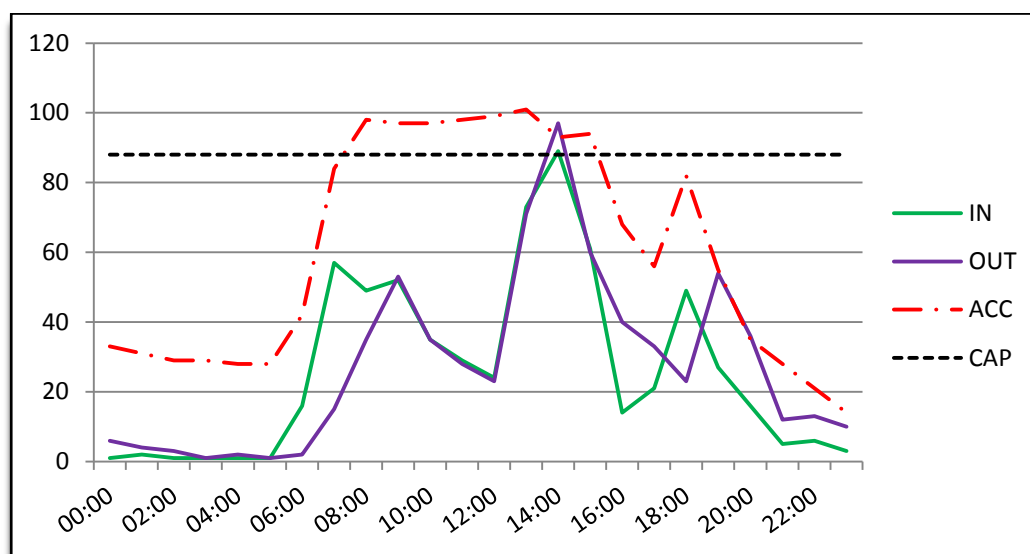
**Figure 4-5: Car Park B Volumes, Capacity and Accumulation**

Occupancy of the car park was 38 vehicles at 00:00 hours from which time classified counts were done for vehicles entering and exiting the car park. The survey results are summarised in hourly intervals in Table 4-3 below. The results show that between 08:00 and 15:00 that the car park is over capacity with a peak occupancy of 115% at 13:00.

Traffic arriving and departing this car park follow a similar pattern, throughout the day. The peak period demand for this car park is noted to be between 13:00 and 15:00. Car Park B is also over capacity with the Figure 4-5 above showing that car parking demand exceeds supply between 08:00 and 15:00.

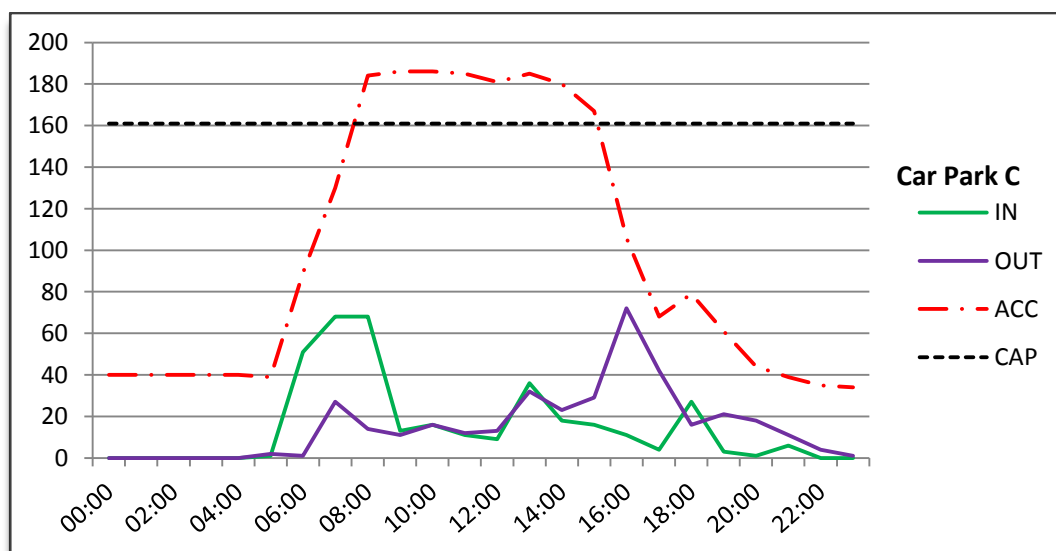
Figure 4-6: Car Park C, Volumes, Capacity and Accumulation

Occupancy of the car park was 40 vehicles when observed at 00:00 hours at the start of the study. Manual classified counts were made for every vehicle entering and exiting the car park. The summarised counts are displayed in hourly intervals in Table 4-4 and in Figure 4-6. These results indicate that between 08:00 and 16:00 the car park is over capacity with peak occupancy being around 116% for much of this period.

Further analysis indicates that the highest demand for car parking space was recorded between 13:00 – 14:00 hours where the parking accumulation reached 114% of the available parking spaces. On the other hand, the least demand for parking spaces was recorded between 01:00 and 05:00 hours at 18% of capacity.

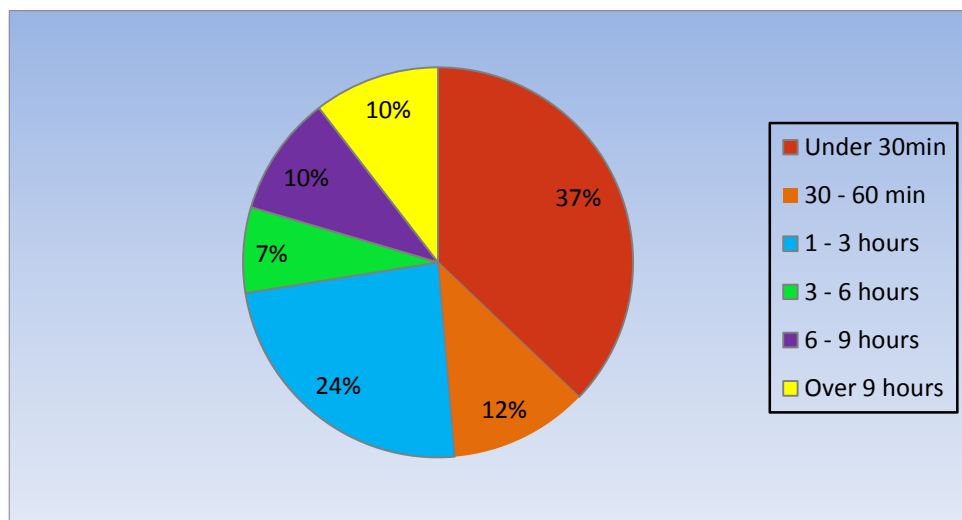
**Figure 4-7: Average Duration of Stay for Vehicles on Site**

Subsequent analysis of the ANPR video footage was carried out and vehicle registrations were matched to give account on vehicle arrivals, movements and durations of stay within the hospital area. The duration of stay and movement of vehicles was obtained by capturing the time at which a particular vehicle crossed one site location to the time the same vehicle crossed another site location around the hospital which information was later grouped into the different time segments as shown in proportions in Figure 4-7 below.

It has been assumed that any movements through site 2 which were recorded as being less than 30 minutes are internal movements and have not been included within the duration of stay analysis which is presented in Figure 4-7 on the previous page. Duration of stay records for movements not passing through site 2 are assumed to be pick-up/ drop-off or servicing. . From the same figure, it shows that approximately 50% of vehicles arriving at the hospital stay for less than 60 minutes compared to 20% of vehicles that stay for long durations (6 – 9 hours and over 9 hours), which are likely to be associated with hospital staff.

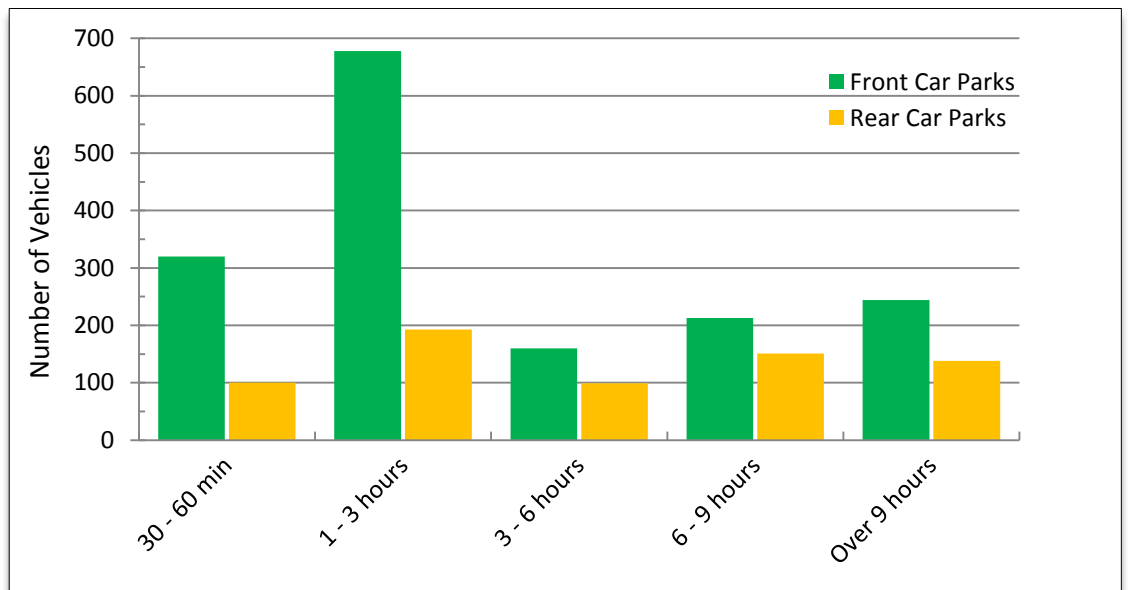
**Figure 4-8: Car Park Duration of Stay**

Further analysis of the survey results from both the Front and Rear car parks identified vehicles staying 1 – 3 hours making up a big proportion of duration stays where a total of 871 vehicles (38%) were recorded to park within this duration as is illustrated in Figure 4-8 overleaf.
